DESIGN INSTALLATION SYSTEMS, INC.

re:news

PROJECT SPOTLIGHT

December 2005

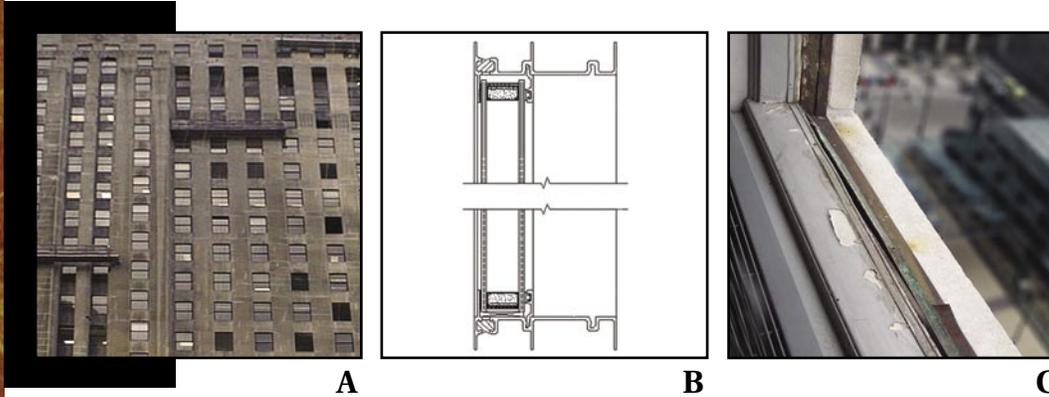
This Madison Street building (See photo A) was built in the 1920's and has over 1500 vintage windows. When it was decided to begin a replacement program, the owner called DIS. The window replacement work would be an important part of a major remodeling project. Design Installation Systems was asked to assist in this and to conduct any required exterior work as part of the window replacement program.

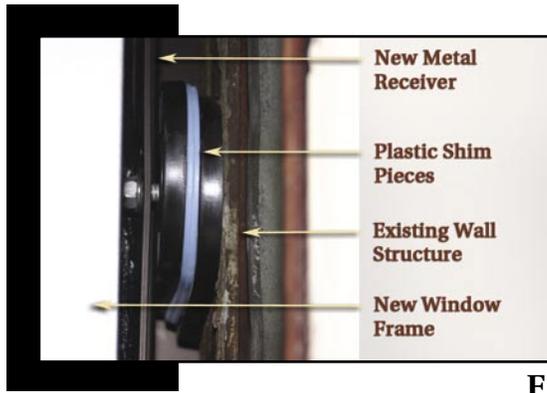
F

Once the old window and frame are removed, the opening is cleaned and prepared. The existing wall structure is now ready to accept the new window. At this stage of the construction, the hole in the wall is referred to as the "rough opening." In this installation (See photo F), an extruded metal receiver is installed in the rough opening. The receiver will accept the new window frame and must be plumb, level and the correct size. To make up any difference between sizes, plastic shims are placed between the rough opening and the receiver at the fasteners.

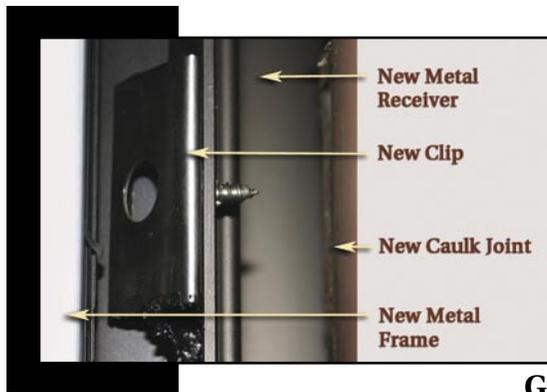
G

The new window frame (See photo G) is fully glazed and ready for installation. It is swung into place and held firm with clips. Any intersection between building elements is caulked; this helps to reduce air infiltration from the outside.

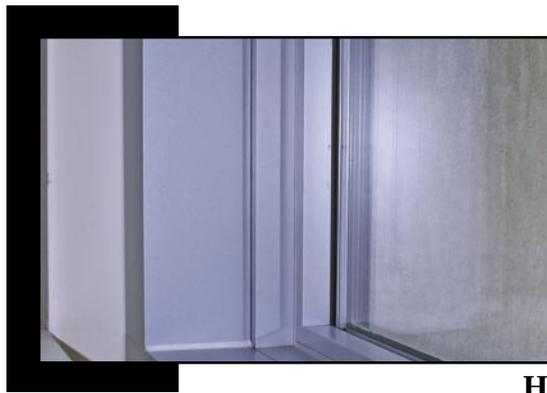
H

Once the window is in place and all caulking work has been completed, metal trim pieces are installed. The finished installation shown (See photo H) will be further enhanced using trim or caulk as a transition between the metal and the drywall.

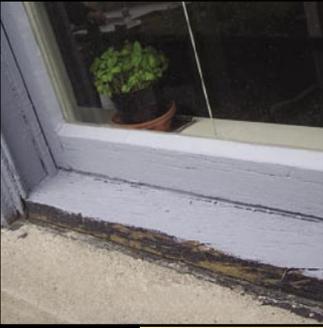
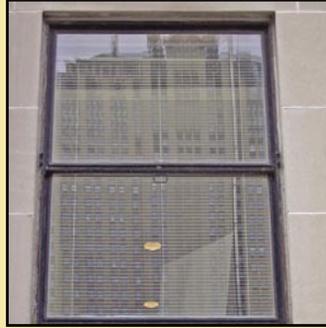
Windows are an important element of most buildings, and many common problems reported by building owners and tenants alike relate to windows. Cracked panes, rotted frames, drafts and leaks (See photos I & J) windows are a maintenance concern. When windows are left unattended, leaks will lead to added deterioration of the wall system and can cause mold and water damage to interior furnishings.
