# re:news

## THIS MONTH'S FEATURES:

- CBOT RESTORATION
- MASONRY REPAIRS
- DIS AND INDUSTRY STANDARDS

## INTRODUCTION

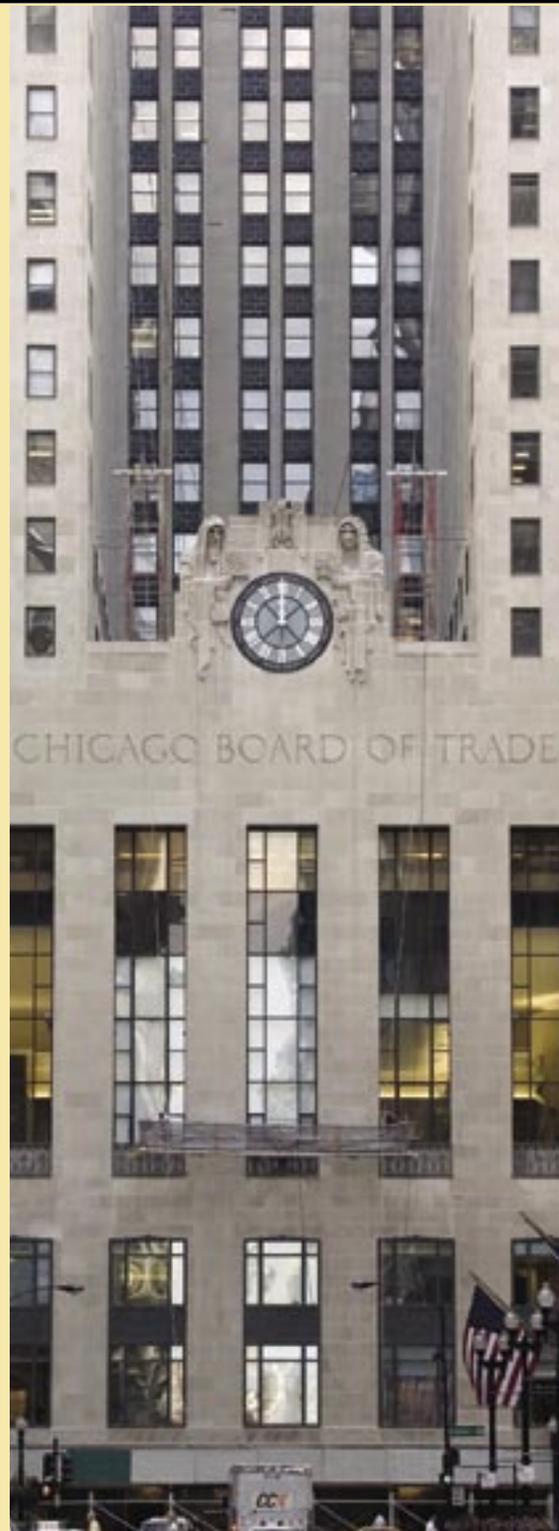
The commission's website refers to the building as "one of the city's finest examples of Art Deco architecture, a style of the 1920s and early 1930s that attempted to express the modern, streamlined world by the use of cubic forms, geometric ornamentation, and sleek surface materials." The CBOT was designated a Chicago Landmark on May 4, 1977 and fits the Art Deco definition perfectly. Its sleek stone and terra cotta façade and ornamentation are the focus of the work being completed by DIS.

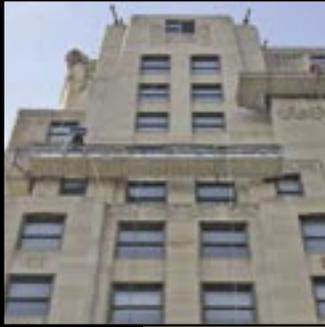
*The north elevation of the building contains a large percentage of ornate cut stone. In addition to the large stone eagle, there are a number of stone statues and specialty pieces.*

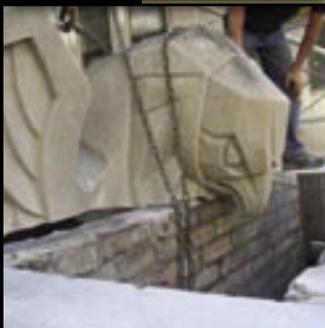
*The capstone was moved only a few feet back to allow for work on the north façade. The interior wall cavity also was examined and refurbished.*

*The capstone (as viewed from the roof) shows how the eagle looks out over LaSalle Street.*

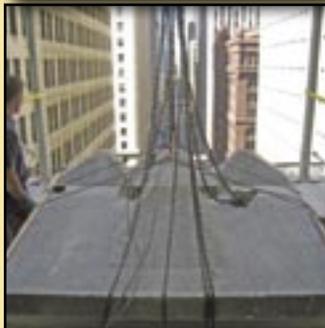
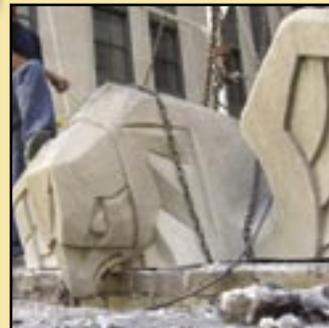
*At the top of the clock tower there is an extremely large capstone. Weighing approximately 5,000 pounds, this stone is the “face” of the eagle. Removing and resetting this piece was just part of the challenge when it was decided to replace some of the steel supports in the clock tower wall.*

The front of the eagle assembly consists of three stones: two shoulder stones each weighing 3,500 pounds and a third vertical stone. The third stone—the main piece—is larger and ornate. The entire 7,300-pound stone is a deep relief of the eagle's body. The smaller shoulder stones were removed and carefully placed on the roof, waiting for the removal of the final piece and replacement of the steel. The main piece, once removed, was left attached to multiple chain hoists and steel cables while its weight was supported by temporary steel beams bearing on the clock tower structural wall. Only after replacement of the structural steel supports inside the north wall could the tower stones be reset.

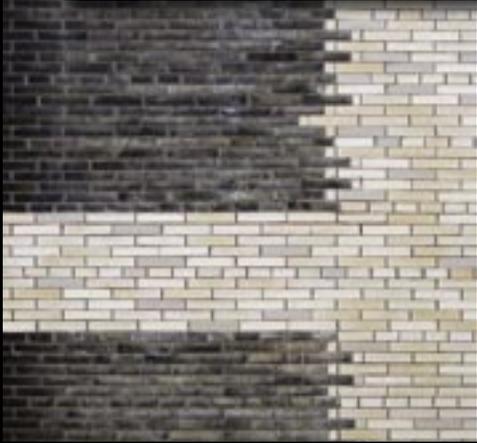
*This photo shows the new brick blend provided by DIS. Once cleaned, the dirty original brick will blend with the repair area much better. We know this because we blended the new brick by hand from three different sources and matched the existing color range from the area we cleaned for that purpose.*

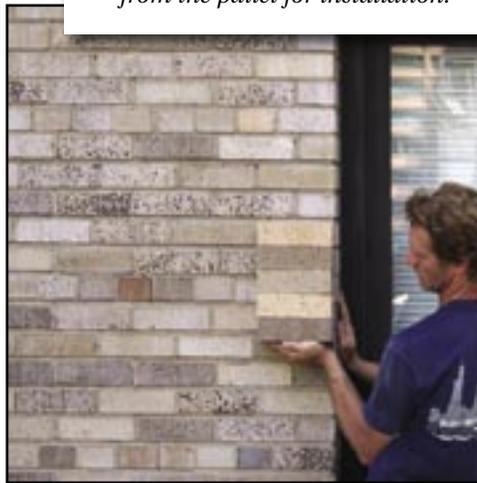
*This blend of brick is single sourced; one supplier provided all of the brick for this job. However, since there are three different colors, DIS specified how many of each type was needed and what order they would be placed onto the pallets. This allows for proper blending as the mason removes them from the pallet for installation.*

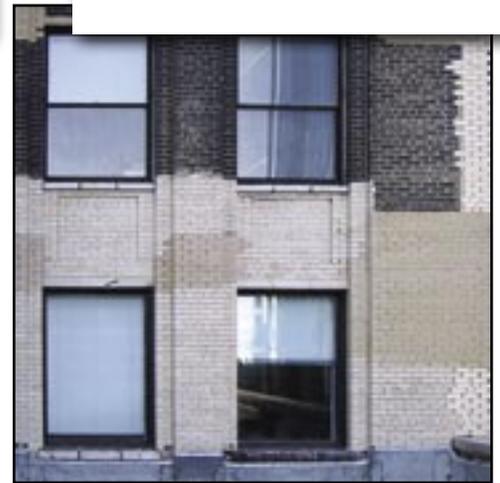
*After cleaning a representative area of brick, DIS discovered that previous repairs were done without a proper brick match. This immediate area consists of original brick (clean and dirty) and three different colors of new brick.*

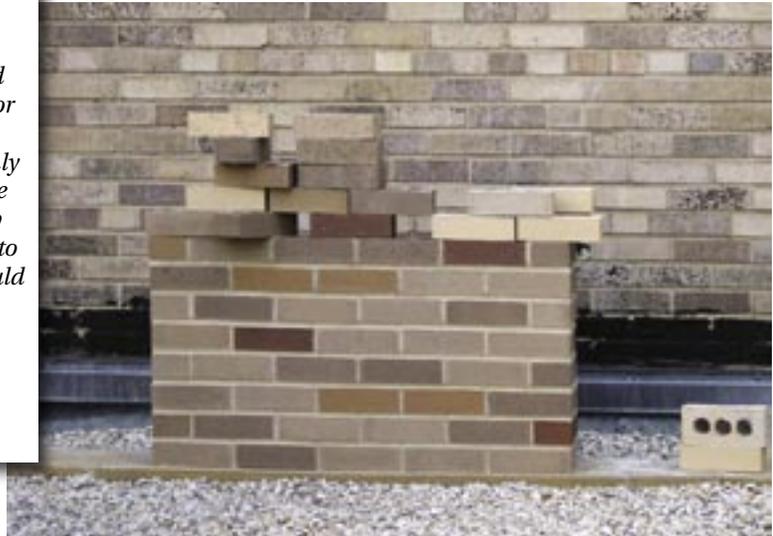
*This mockup shows how the brick can be presented to the owner. The contractor provides choices for the owner and designer, but only the owner can approve the brick. Building a mockup sometimes makes it easier to visualize the brick as it would sit in the wall.*

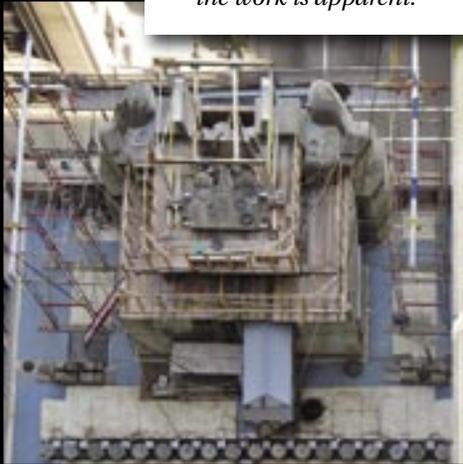
*Looking down from high above the clock tower and facing north and out over LaSalle Street, the set-up for the work is apparent.*

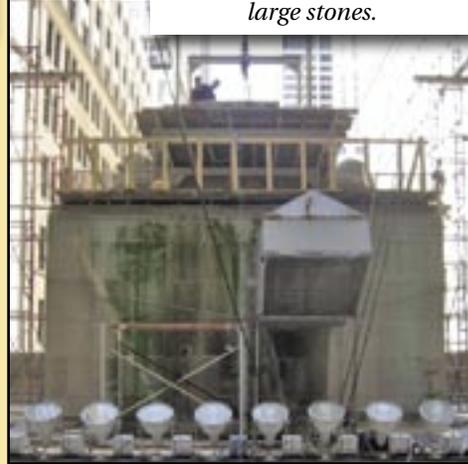
*This view, from the roof side of the clock tower, shows the DIS equipment needed to accomplish the successful handling of these large stones.*

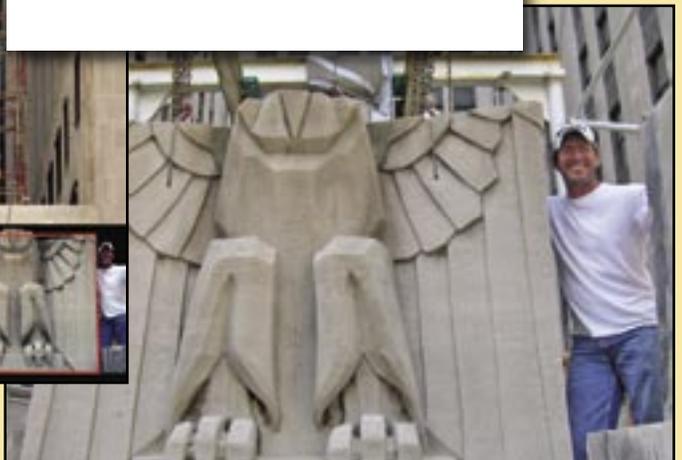
*This stone dwarfs our DIS stone mason. Careful and accurate handling is the key to removing and resetting these large pieces.*
