# re:news

### 233 EAST WALTON

December 2006

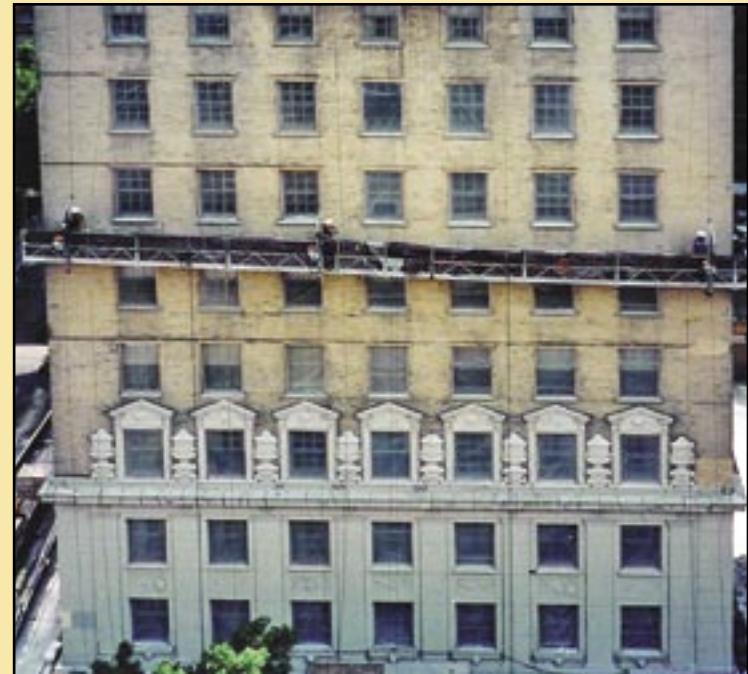
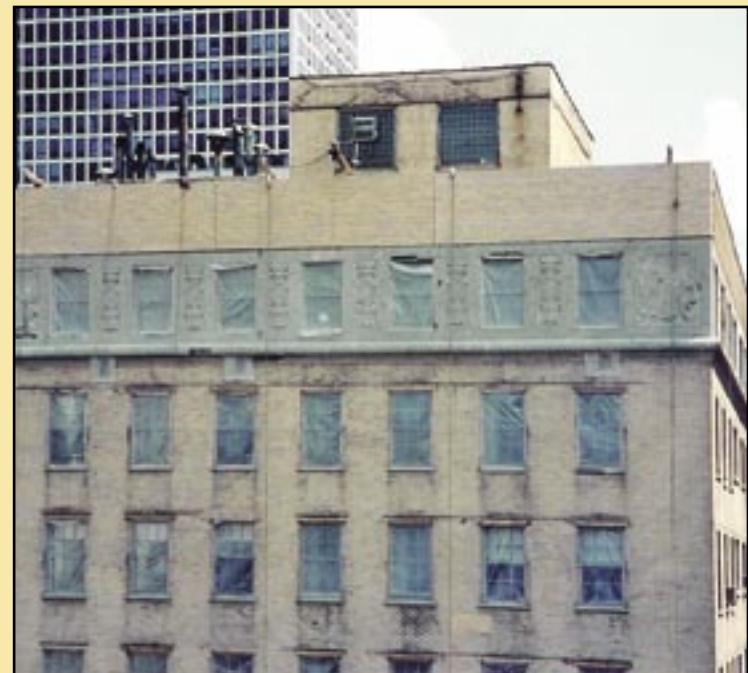
*These photographs were taken near the start of the first project DIS was involved in at 233 East Walton.*

*Note the deterioration of the face brick and window sills. The supporting steel angles also were severely corroded and required replacement as the masonry wall was removed and rebuilt.*

*At the base of the building, on the north elevation, the facade is decorative stone. Replacement pieces were precast in our shop and installed by DIS. This portion of the facade was painted with a protective architectural coating. The remaining portions of the two faces were masonry and required 100 percent rebuilding.*

*Windows were protected and left in place, so that the work could proceed with a minimum of disturbance inside the unit. The building was in use as a residence during all phases of this project.*

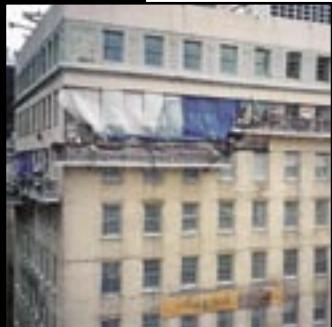
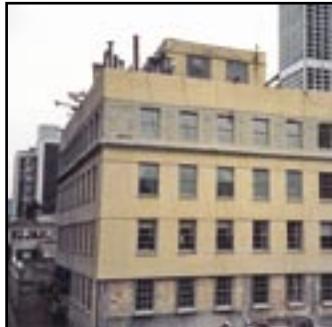
*The two faces were rebuilt floor by floor, from the parapet wall to the ground. In addition to that work, the rooftop penthouse was worked on, and some structural beams on the roof needed major restoration. All work was completed by Design Installation Systems' skilled craftsmen.*

The 233 East Walton Building is a 1920s vintage 14-story residential building. Like many buildings of the period, its steel-reinforced concrete and brick structure was covered by brick masonry. The face brick and steel lintels on the two street sides of the building were showing their age. A good cleaning would have made the facade look better but would not address the real problem: movement in the facade caused by the expansion of steel angles as they grow with rust. Because the deterioration of the steel lintels and shelf angles was widespread, it was decided to strip all of the brick rather than trying to stabilize and preserve the areas around the work.

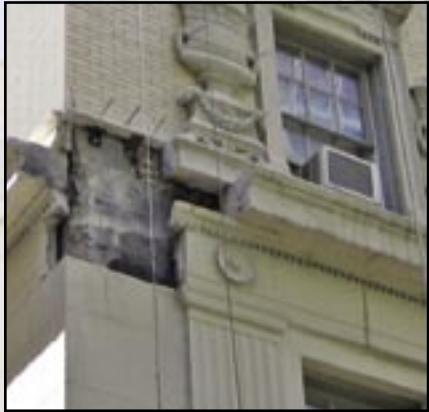
*Pictured here is a section of the 2004 Prototype repairs. The test project went well and in 2005 a project was launched to completely rebuild the stone bands on the 4th and the 14th floors.*

As the successful bidder, we began work on limited areas of the bands as prototype repairs. This small scope of work allowed the engineer and owner to review the work and decide whether or not the work could be done on a larger scale and within the budget. Fortunately the prototype work progressed well, and the scope of the next project included all of the remaining portions of the decorative bands.

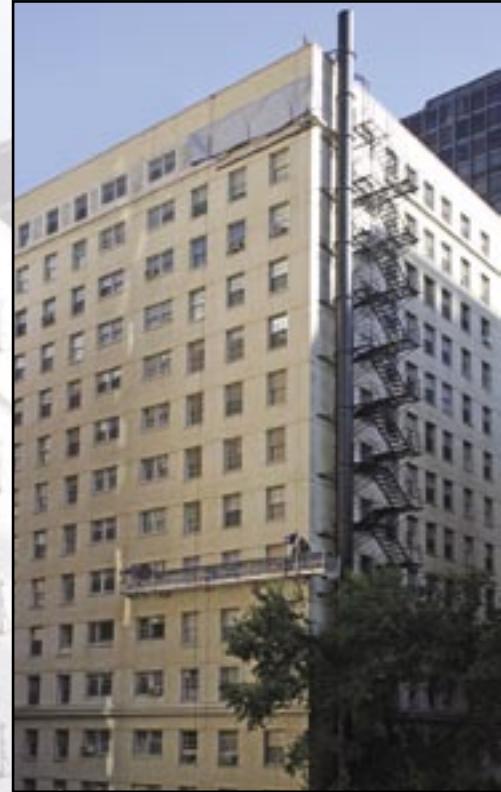
*This photograph of the west and south (fire escape) sides of the 233 East Walton Building shows one tarped area currently under construction.*

*The photo includes one side that was rebuilt in 1997 and another side that was not. The upper band being rebuilt is on the west elevation where brick was rebuilt nine years ago. Replacing the 4th- and 14th-floor decorative bands completes the rebuilding on this elevation.*

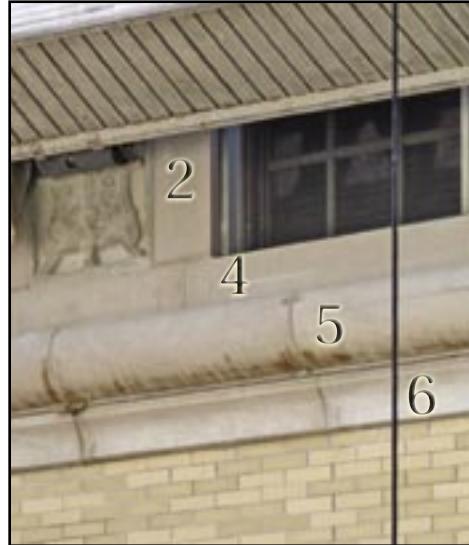
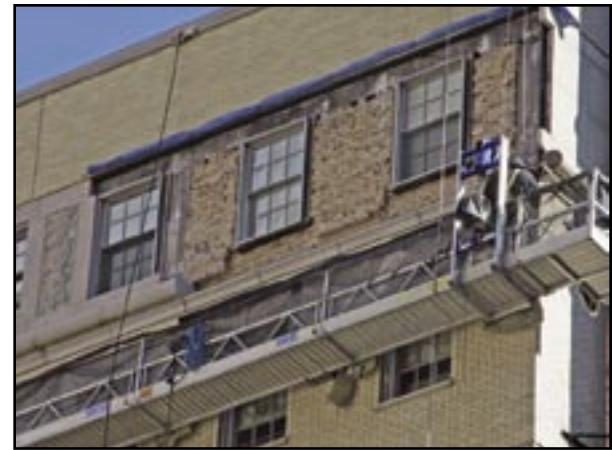
The original pieces in these bands were made of precast concrete and were painted. In poor condition, most existing pieces would not have survived removal to be reinstalled. A decision was made to replace the existing pieces with limestone and to fabricate new "picture" pieces to emulate the old pieces. This way, the natural materials could be left uncoated, complimenting the masonry.

The bands consist of a number of elements:

- 1) Flat Lintel
- 2) Stone Mullion
- 3) Picture
- 4) Sill
- 5) Bull Nose
- 6) Cove Piece

The finished picture panels average about 65" x 48" x 5". They are made by DIS in our shop and transported to the site, as needed, for installation. All stone pieces are cut at the DIS stone shop specifically for this project. These hand made pieces, once assembled, match the profile of the former pieces, but have the added aesthetic value of stone. It was decided that the cast "picture" pieces matched the limestone closely and did not require paint.
