re:news

DESIGN INSTALLATION SYSTEMS, INC. 8110 River Drive • Morton Grove, IL 60053 • 847-470-8100 • www.disinc.net

Vol. 1, No. 2

December 2003

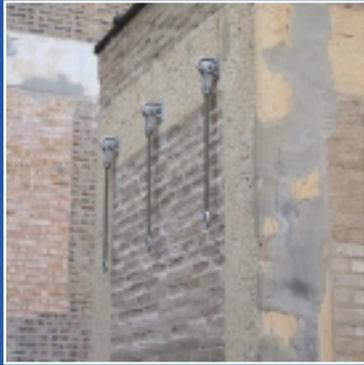
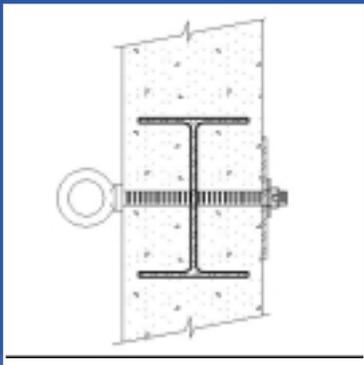
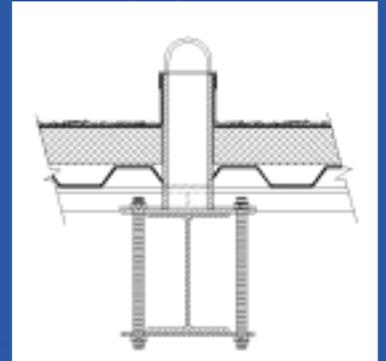
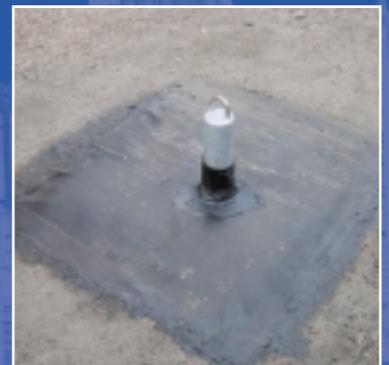
Simple examples of these tiebacks are shown here. These concept drawings may be modified to fit almost any aspect of a buildings roof design. As there are serious life safety concerns involved with the installation of these systems, it is recommended that a licensed engineer be involved in the design and installation process. Safety rated hardware must be adequately integrated into the buildings structure and maintained in such a way as to prevent corrosion or other damage that would lessen its effectiveness over time.

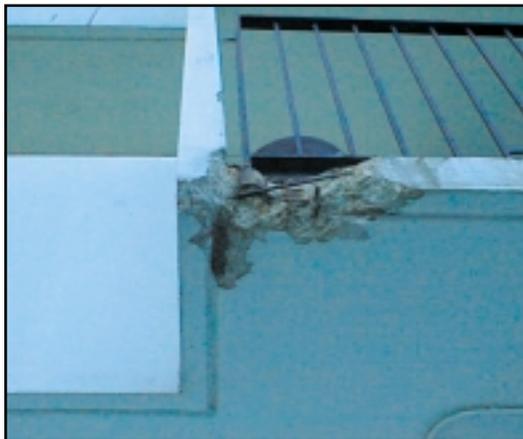
Concrete restoration is completed in phases. The concrete structure needing repair work is first observed for delamination, cracking and spalling. Accessing the work is sometimes no easy task. The building is rigged for scaffolding and life safety equipment. Once that demanding task has been achieved the inspections can begin in earnest. All suspect areas are sounded out with a hammer; hollow or dull sounds indicate problems. Once the areas are defined preparation of the work area begins.

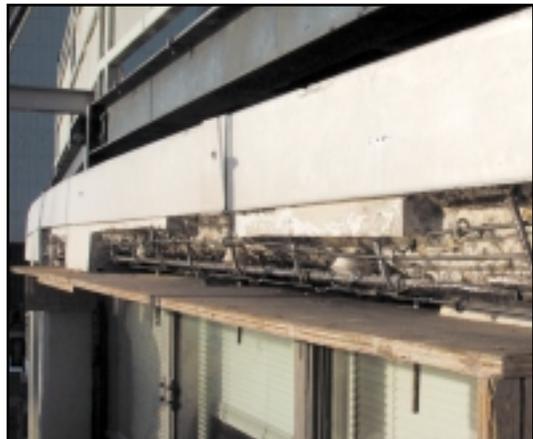
Supplemental anchorage is typically stainless steel. Bolts, eyehooks and threaded rods are all used. Set into epoxy filled holes and lashed to existing steel, the new steel works with the old to reinforce and anchor the patch. All existing steel to remain is cleaned and coated with a rust inhibitive primer. In some cases (as shown above) cathodic protection is added (see "Structural Elements" in this issue). Once formwork is in place the area is ready for new concrete. The concrete forms are custom made from wood, steel or plastic and are designed to remain in place until the fresh concrete has cured enough to retain its shape and hold itself in place.

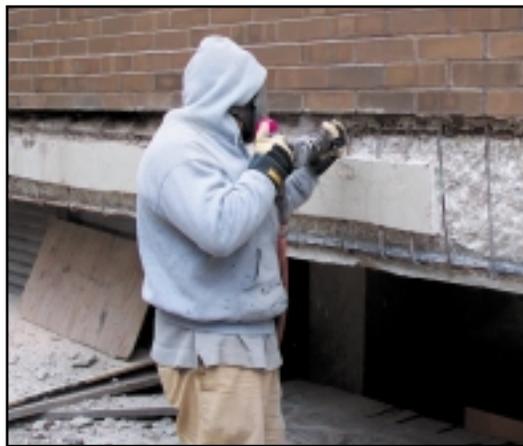
Areas marked for repair are saw cut then chipped into regular shapes. The bad concrete is removed, and then good, sound concrete (parent concrete) is chipped away until the desired configuration is achieved. Removal is done with the final patch in mind; it must be a minimum thickness with sufficient bar coverage, have a certain shape, be able to accommodate supplemental anchorage and reinforcing, and needs to fit into desired esthetic parameters.

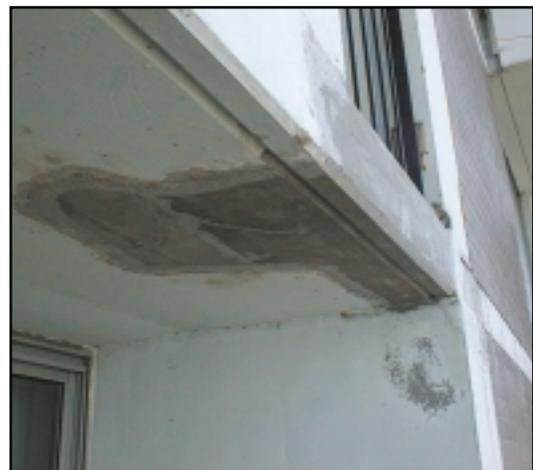
After removal of the form, the concrete is inspected for defects. If needed, the edges are feathered by grinding so they match adjoining surfaces. After a period of curing the concrete is usually painted to protect the new patch. Placing a fresh coat of paint over the patch, then repainting the entire building, protects the concrete and makes the patch difficult to find.

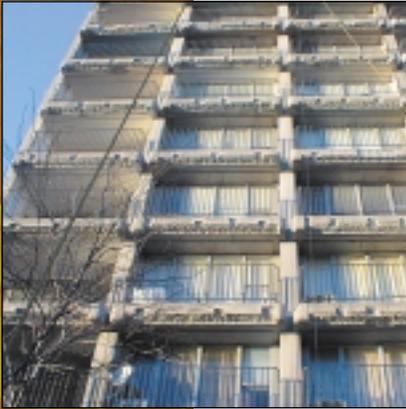
■ 1960 Lincoln Park West, Chicago, Illinois

Client:	Draper & Kramer, Inc.
Consultant:	Klein & Hoffman, Inc.
Assignment:	Concrete & Balcony Rehabilitation
Duration:	3 Years (1999-2001)

This prestigious Lincoln Park building was in need of major concrete rehabilitation. DIS completed a comprehensive concrete repair and coating project over a three year period. Specially made concrete forms were used to match the existing profile of the slab edge and columns. After the concrete work was complete the balcony handrails were repaired and painted. To preserve the repairs, window frames and concrete joints were caulked and all exposed concrete was coated. Decorative waterproof paint was applied to vertical surfaces and a multilayered traffic bearing membrane was applied to balcony surfaces.

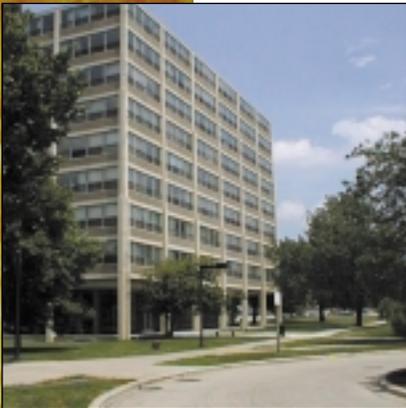
■ IIT, Chicago, Illinois

Client:	Illinois Institute of Technology
Consultant:	Soodan & Associates, Inc.
Assignment:	Concrete Restoration
Duration:	2 years (1998-1999)

This project consisted of four buildings, three of which needed concrete repairs as a major component of the restoration work. Slab edges and columns all needed concrete repairs for spalls and delamination, but in some cases a special compound was used to seal and bridge over cracks prior to painting. This method significantly reduces the cost of repair work and increases the life of the concrete coating. After completion of the concrete and caulking work, the concrete surfaces were coated with a waterproof paint.

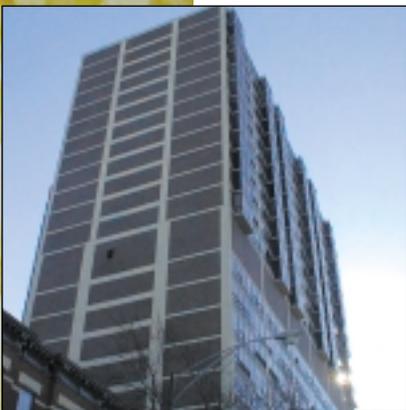
■ Kennelly Square, Chicago, Illinois

Client:	Kennelly Square
Consultant:	Schoengart Associates, Inc.
Assignment:	Concrete & Masonry Restoration
Duration:	In Progress

This near north conversion is a mix of brick and concrete construction. In need of concrete repairs at slab edges, beams and columns; Design Installation Systems was asked to do the work. The comprehensive project included not only concrete restoration, but also had masonry rebuilding and repair along with a great deal of recaulking work at window perimeters. DIS was able to complete all this work without the need for subcontractors and the condominium building has the added benefit of receiving a single source warranty for future repair and maintenance.

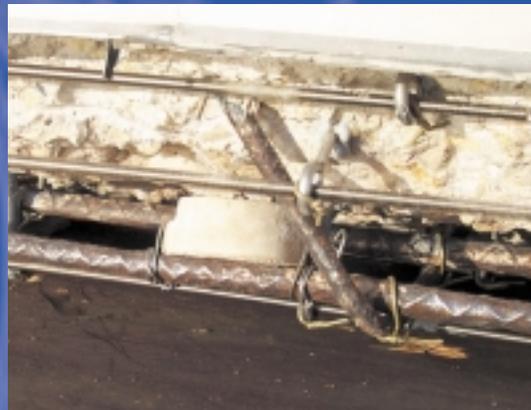
Galvanic Anode in a mortar shell is tied to the reinforcing bar before concrete patch is poured. The anode deteriorates in place of the embedded steel and thereby protects the concrete.

Galvanic CP introduces a metal anode into the concrete that is more likely to corrode than the steel. This method often uses zinc as a “sacrificial metal” deteriorating before structural steel can be attacked. This system is limited only by the amount of anode material cast into the fresh concrete. The deteriorating zinc does not expand and does not become a problem as the process advances.
