re:news

DESIGN INSTALLATION SYSTEMS, INC. 8110 River Drive • Morton Grove, IL 60053 • 847-470-8100 • www.disrestoration.com

June 2004

Structural Elements

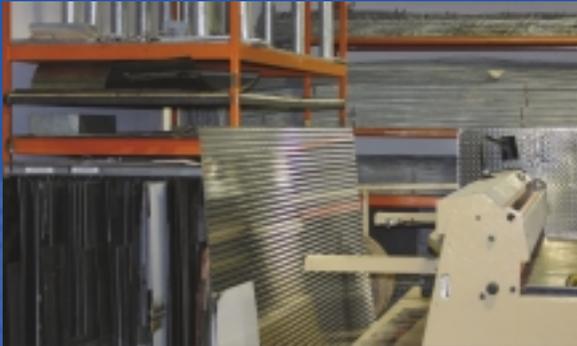
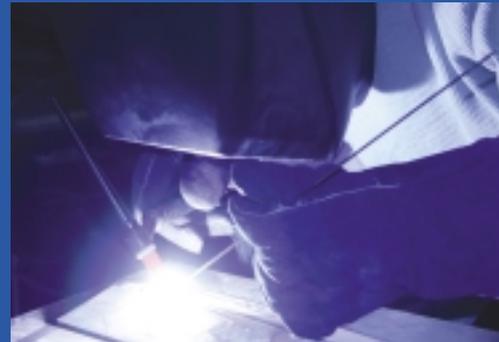
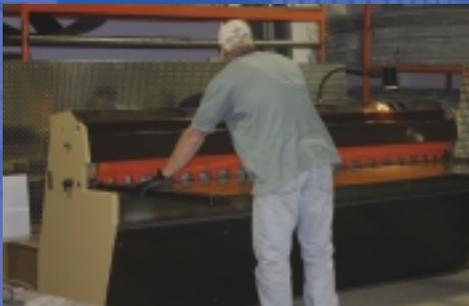
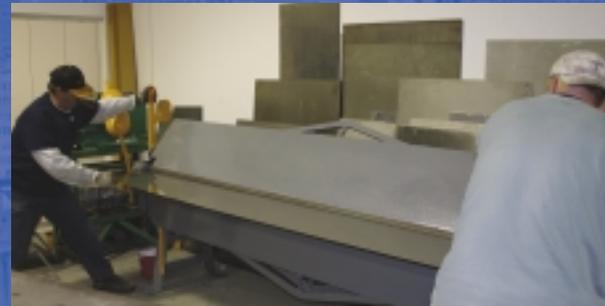
When an item request is brought into our office, the fabrication process begins. Most pieces require drawings, either for the fabricator or for Architect/Engineer approval. Our project manager reviews the requirements and on-site dimensions and delivers a CAD drawing to the shop. The needed pieces are immediately made to order. The sheet metal is cut to fit on large shears and then bent into the required configuration. Hand-shaping, rolling, and spot welding are all provided at our facility.

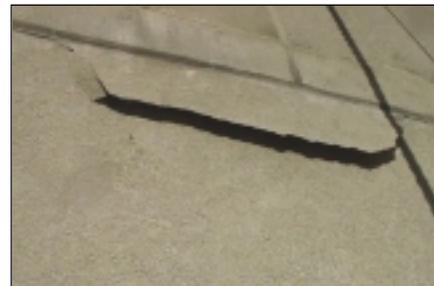
Loose spall in stone (removed during inspection for safety).

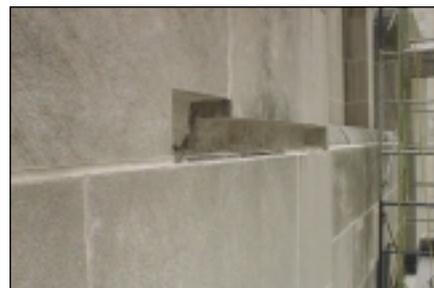
Spalled stones are cut and ready to receive dutchman repairs. The process involves replacing a small portion of the stone with new stones cut to fit and then mortared into place.

After careful hands-on inspections are made, engineers can determine if problems warrant repair of the stone or if replacement is the preferred option. Repair of limestone, marble, and granite can include dutchman, patching, caulking, and tuckpointing. In situations where the stone is undamaged but its attachment to the backup structure is in question, supplemental anchorage is sometimes installed. These retrofit anchors tie the stone back to the structure without having to remove the stone.

When stone replacements or stone dutchman repairs are needed, we supply our own custom fabricated pieces, which are cut in our shop from our stock. This in-house fabrication often reduces our time for completion by 4 weeks or more on simple, flat pieces. Lead-times for custom profiles are reduced by 6 to 8 weeks.

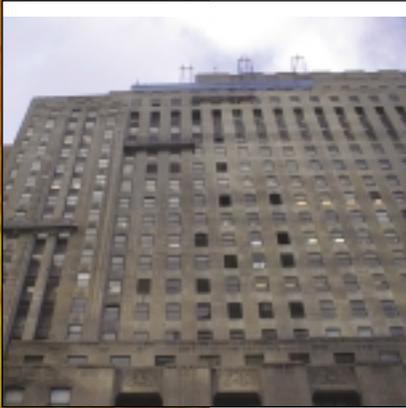
■ Two North Riverside Plaza, Chicago, Illinois

Serving as the building owner's headquarters and gateway to thousands of rail commuters each day, Two North Riverside Plaza was again in need of extensive stone maintenance. As a result, ownership turned to Design Installation Systems to complete a comprehensive program including limestone repair and replacement, tuckpointing, and caulking. A considerable amount of limestone dutchman repairs were installed on the facades along with full stone replacements. As the project progressed, many of the parapet walls were found to be in need of major repair and thus were rebuilt.

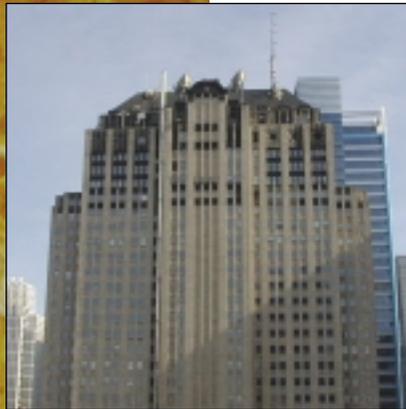
■ Civic Opera Building, Chicago, Illinois

The historic Civic Opera Building located on the Chicago River is currently undergoing extensive limestone and terra-cotta restoration. Design Installation Systems has done maintenance on this landmark for years and is currently in the early stages of a 4-year repair program. The repair and maintenance program currently underway is focused on stabilization and replacement of stones. In keeping with the character of this fine building, the profile of each replacement stone is carefully matched to the original. Additional caulking and tuckpointing work will help to protect the building from the harsh weather typical to the building's riverfront exposure.

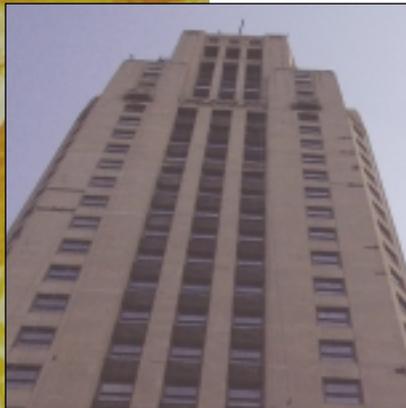
■ 333 North Michigan, Chicago, Illinois

Corrosion of steel shelf angles and lintels within the walls of this Michigan Avenue treasure was stressing the limestone facades. Design Installation Systems was asked to complete a facade restoration project that included steel repair and replacement. Stone work included pinning limestone panels, repairing spalled stones, and full stone replacements where panels could not be salvaged. The work also included parapet wall repairs and rebuilding. To help keep the walls leak free, tuckpointing, sealant repairs, and crack repairs were completed at selected areas on each elevation.
