re:news

NORTHWESTERN UNIVERSITY MONTGOMERY WARD BUILDING

September 2004

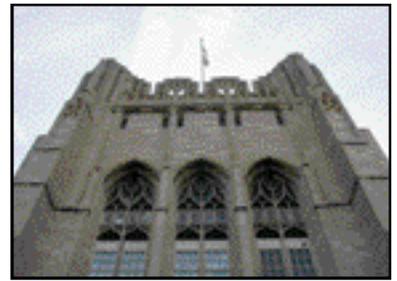
The project documents, as prepared by Wiss, Janney, Elstner Associates, describes the building as: "...an office and laboratory building for Northwestern University that was built in 1925. The main structure is 15 stories tall with an additional 5-story tower at the center." The building is clad in limestone and shows normal signs of aging. Areas of most concern are cracking stone around window heads and stress cracks at some corner locations. Although not uncommon in a building this age, the owner was knowledgeable in these matters and knew that when signs of deterioration are visible, conditions could worsen rapidly. Water entering these openings in the wall would eventually lead to major problems.

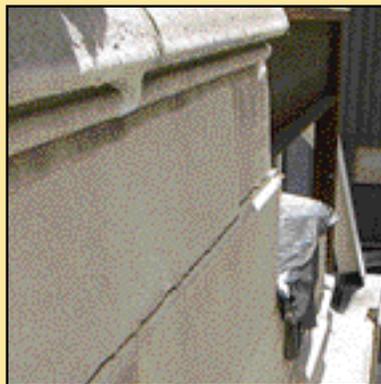
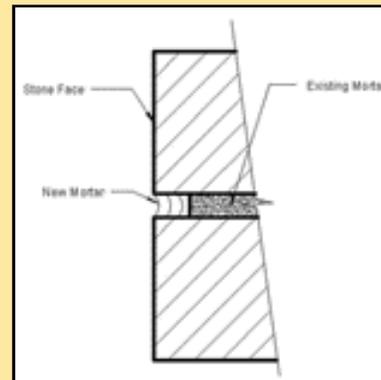
Mortar joints throughout the façade are to be tuckpointed. Some open joints in the walls had been allowing water into the wall system. Although leaking into the building may not occur in these areas, water in the wall system has led to deterioration of steel supports and washing out of adjacent mortar. Tuckpointing is the most efficient and economical way to avoid these more complicated repairs.

Tuckpointing or repointing involves grinding out old, deteriorated mortar and refilling the joint with fresh mortar. The procedure must be completed with great care as it is important to remove all old mortar from the stone without chipping or cutting the stone itself. Depths of cuts change but are normally around $\frac{3}{4}$ inch. Tuckpointing mortar is used to repack the joint and is placed in $\frac{1}{4}$ inch lifts.

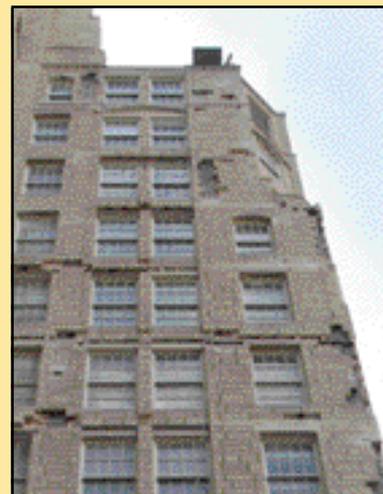
Even with numerous stones removed, the wall remains stable and weather tight. This can only be accomplished with proper planning and careful execution. Remaining stones are braced and openings are sealed against wind and rain.
