DESIGN INSTALLATION SYSTEMS, INC.

re:news

PROJECT PROFILES

December 2004

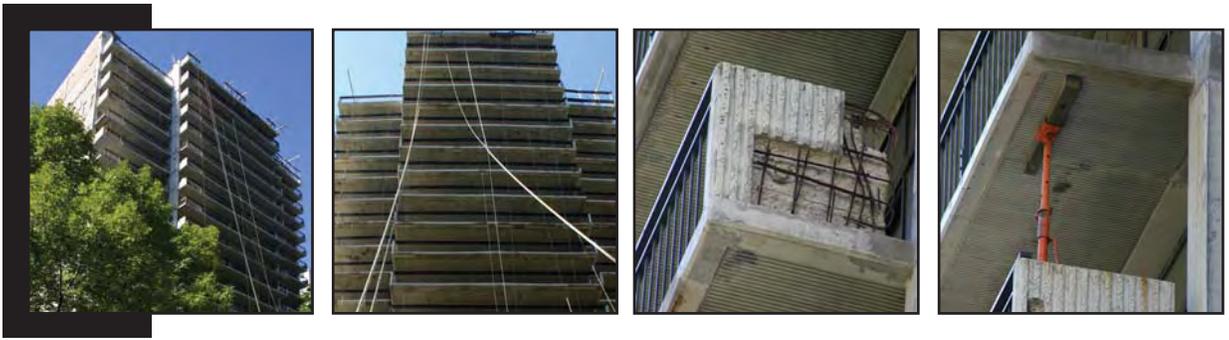
1430 NORTH ASTOR

This north shore condominium building is a single phase repair project with concrete work completed in 2004 and coating work to be completed in the spring 2005. Design Installation Systems was contracted to complete concrete restoration work on the south and east elevations. The work included a good deal of balcony restoration, specifically the inspection and refurbishment of the railing systems, deck preparation, and coating and re-caulking work. Where balcony walls needed work, balcony doors were sealed to prevent exposing unit owners to any unsafe conditions. On decks where slab tops or slab undersides needed repair, balconies were shored to prevent collapse.

Water resistant coating will be applied to concrete surfaces after completion of the concrete repairs. Coatings of this type are painted on to protect the concrete and patched areas as well as to give the building a uniform appearance. These coatings are available in a wide variety of standard colors and can be custom mixed to almost any color, making it possible to touch up existing coatings. It is recommended that all concrete facades be coated in some way to help protect them against the damaging effects of weather. Coating work must be completed only after repairs have completely cured and moisture tests have been completed.

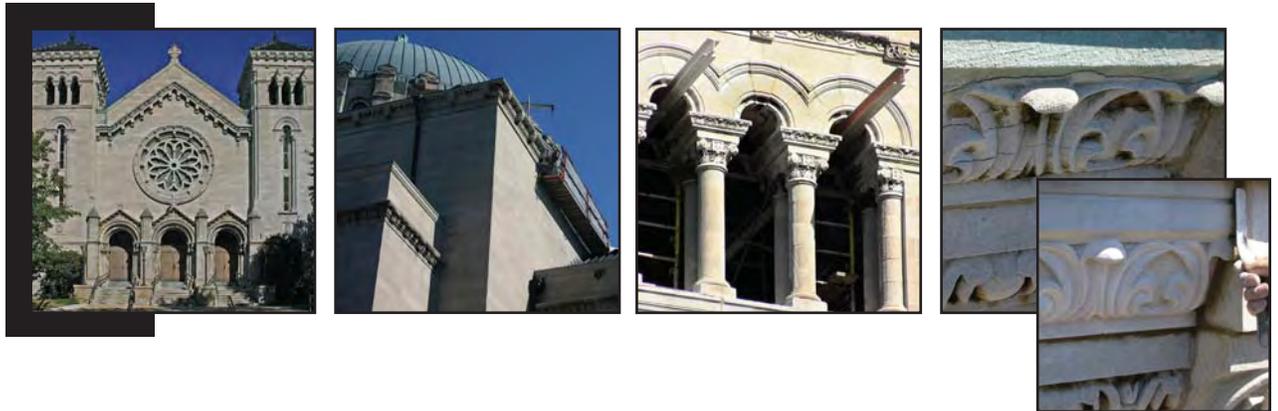
ST. CLEMENT CHURCH

This is a project that got its start well before the 2004 construction season. Preplanning and early material orders were the only reason this project was completed in one construction season. Some of the intricate stone needed to be hand carved and the long lead times involved required that the orders be placed while the snow was falling in early 2004. The planning and bidding work were completed well before most projects were finalized this year; that allowed Design Installation Systems to hit the ground running in the spring.

Stone replacement and tuckpointing work was the main emphasis of this project. Work also included stone patching and pinning. Hand patching stone is an art form, and as such DIS has craftsman trained and experienced in methods which make patched stone blend in extremely well with adjacent stone. Pinning reinforces stones left in place and is often used in conjunction with the stone patch.
