re:news

DESIGN INSTALLATION SYSTEMS, INC.

OCTOBER FEATURES

- **DIS SERVICES**
- **PROJECT PROFILES:**
233 EAST WALTON
105 WEST ADAMS
- **EMPLOYEE PROFILE**

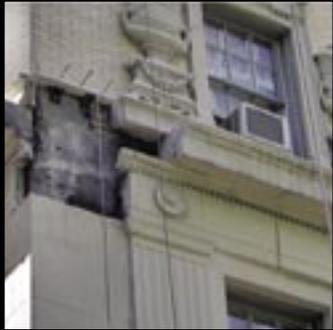
A

This northside building is a beautiful brick structure. *(See photo A)* When carved stone and precast concrete restoration was needed, Design Installation Systems was called. DIS previously had replaced the entire brick face on two sides of this building. Replacement and resetting of other remaining elements are a natural extension of that work. It is important to keep the surrounding masonry stable during the removal work. *(See photo B)* Prior to beginning the removal, holes are drilled through the brick into the structural backup. Stainless steel rods are then placed into the holes at regular intervals. These rods will support the brick above until they are removed at the end of the process.

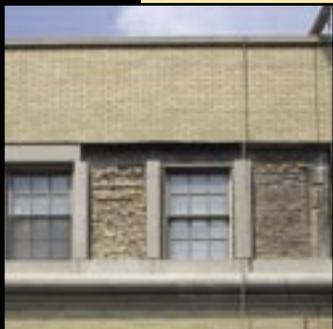
D

In selected areas, limestone panels had been chipped or displaced by expanding metal. Removal of the affected panels is followed by rehabilitation work. First the backup masonry is checked and tuckpointed as needed. Any existing steel supports are cleaned, primed and painted. Angles are replaced if they are not serviceable. When being rebuilt, new elements, such as flashing, are installed; then panels are reinstalled and tuckpointed and/or caulked into place. Although limestone replacements are sometimes used to replicate other materials, other materials are not normally used to replace limestone. Here old limestone panels will be replaced with new limestone panels. *(See photo D)*

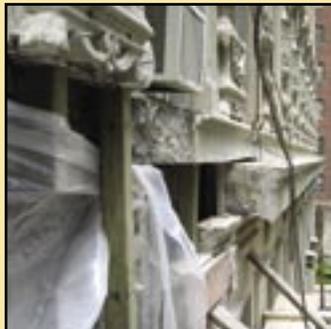
E

This open section of wall *(See photo E)* gives a clear view of the end sections of the existing concrete pieces. The plastic sheets in the picture are used to keep wind and rain out of the opening and prevent damage to the interior of the building. In projects such as this, the building remains occupied during the work. Although air conditioners are sometimes covered for short periods and windows may be temporarily covered, the building can be used continually during the work. During demolition, some noise is transmitted into the building but is limited in severity and duration.

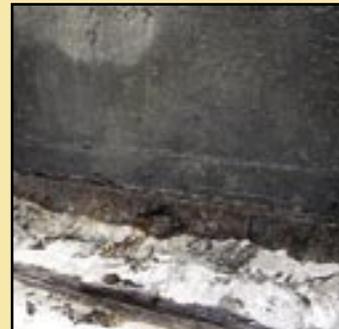
F

Most of the time, problems within the wall system can be traced back to expanding, rusted steel supports. Like many buildings of this vintage, steel within the wall has suffered corrosion. (See photo F) The extent of the delamination varies from area to area, but when it is found, there are ways to deal with it. After repair or replacement, the steel is painted and flashed to provide long-term protection. Additional information dealing with water infiltration and its effects and repair methods can be found in previous issues of this newsletter. Please call our office at (847) 470-8100 for reprints.

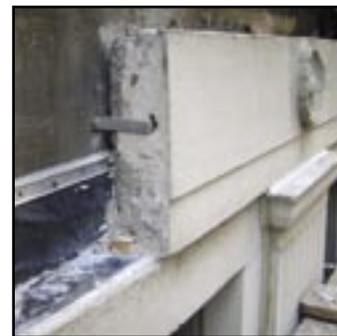
G

Once the steel support angles have been replaced or refurbished, the repair begins in earnest. (See photo G) In the event that water enters the wall system from above, the black flashing will redirect the water out of the wall system. This flashing not only prevents water from finding its way into the building, but it also helps to protect the angle from rusting. At the top of the flashing is a termination bar. The aluminum or stainless steel strip is fastened to the wall over the flashing and then caulked. Protecting the horizontal “water edge” on the vertical flashing is very important, ensuring that the flashing will remain in place. The last item of interest in this photograph is the stainless steel strap. This strap is embedded into the stone and then mechanically fastened to the concrete building structure. This stabilizes the stone and prevents it from moving, even if the mortar cracks and fails over time.

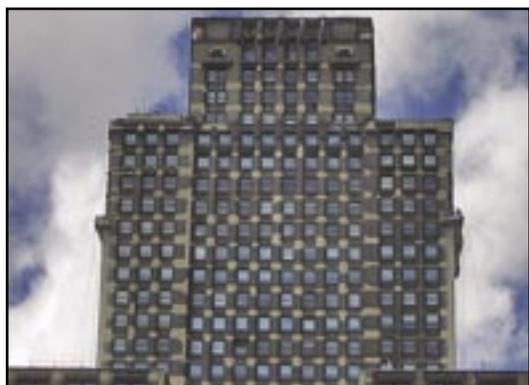
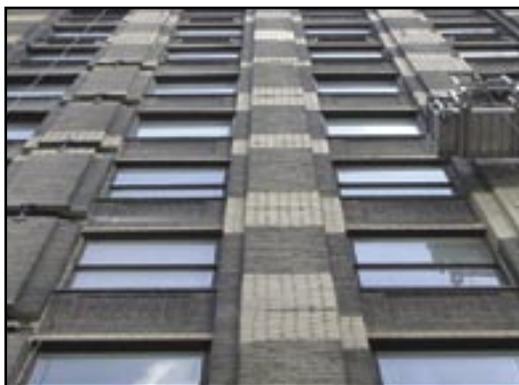
This Loop high-rise stands as a masonry and terra cotta clad building with a concrete and steel structure. (See photo H) This 41-story building has stood at Adams and Clark streets since 1927. Over the years, the exterior masonry has acquired a dark appearance from atmospheric contaminants. Masonry maintenance and replacement over the years have been completed using a number of different colors of brick. Past masons have either not tried to match the repair materials to the clean original, or have tried to match whatever shade of dirty brick that was in the area of work. Design Installation Systems believes that when we leave a repaired building it should not look like a repaired building—it should have the look of a building restored to its original beauty. In an effort to make our preservation mix seamlessly with the original construction, DIS craftsmen are blending seven different bricks to come up with a match for the original brick color, texture and pattern.

These photographs (See photos H and I) show the stark contrast between original masonry and rebuilt areas. However, in the not-so-distant future, the building will be cleaned. Once the building is cleaned, the contrast will be eliminated, and the facade will regain its original appeal.

The strategy being implemented by Design Installation Systems has been to clean a sample area of the building and match the new brick to the original color. By doing this, when cleaned, the building will look more like it did when it was first constructed. The same idea holds true for repair mortar and tuckpointed joints.

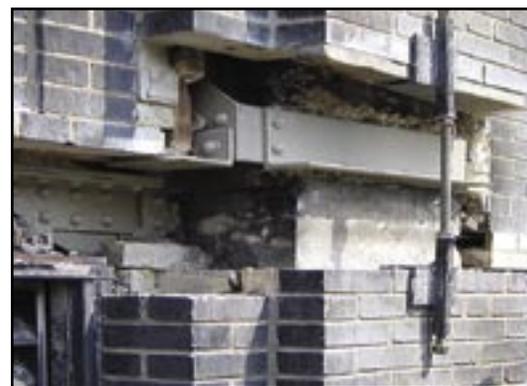
J

This photograph (See photo J) shows many aspects of the restoration of masonry walls. We have discussed some of them in detail in past issues. Here we see supplemental steel supports being used during the repair to keep masonry adjacent to

the work stable. We also see new and existing steel supports that will be left in the wall, unseen but vital to the installation. The steel has been fabricated, primed, painted and installed by DIS without the need for subcontractors.

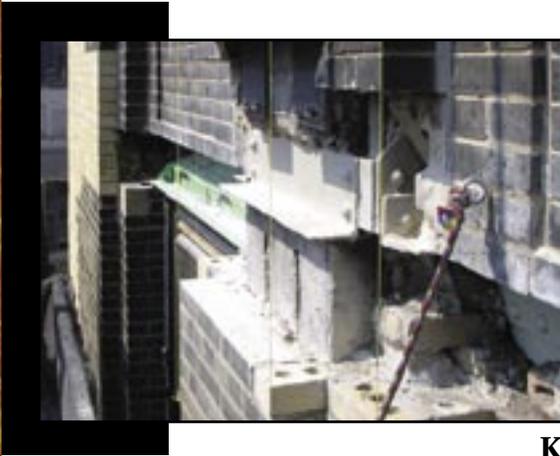
K

As with most buildings, the type of construction and means of rebuilding are the same, but the details change. All buildings are different, and specific details need to be drawn and followed during the restoration. In this application, windows are immediately adjacent to pilasters (columns set into the face of the building). (See photo K) This configuration causes some ins and outs that are visible on the facade, having been translated into the steel from the backup structure of the building.

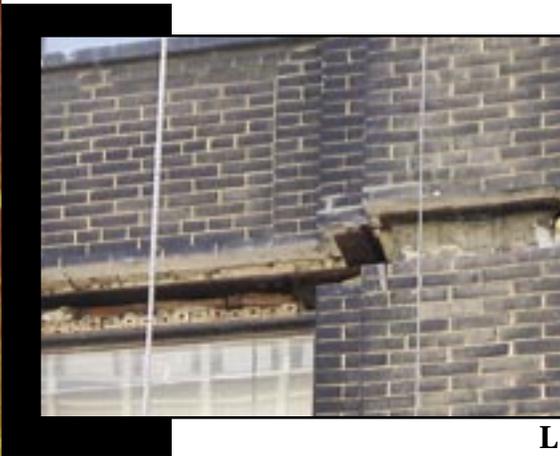
L

After removal of the brick, and prior to any restoration work, (See photo L) one can see exactly how the brick is totally supported by steel. Brick masonry cannot simply be stacked upon itself, as it is not strong enough to support its own weight.

Masonry must be supported from floor to floor by “shelf angles.” In addition, there must be support over openings in the wall; these supports are called “lintels.” Typically in this type of construction, lintels and shelf angles are steel angles bolted to the backup structure. In the past, angles were very often not painted or flashed into the wall. This leads to problems because the steel begins to rust.

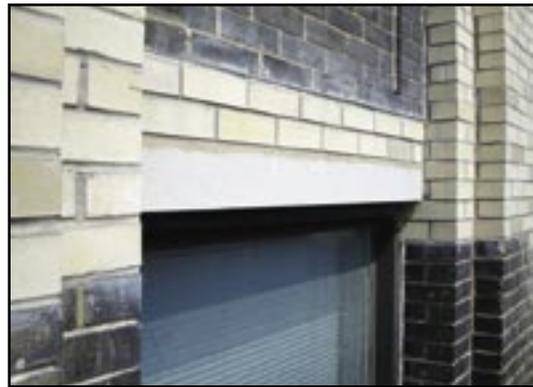
M

Finished window lintel work includes surrounding masonry. This close-up view (See photo M) highlights the contrast between the old and new masonry.

Although cleaning the building is not part of the current project, the building owner has anticipated that job for a future project. Forward thinking led the owner to choose a color for the new brick that best matches the building in a cleaned state. After cleaning, the brick colors will not be nearly this stark, and the facade restoration will be truly completed.

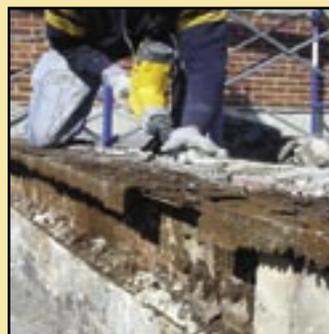
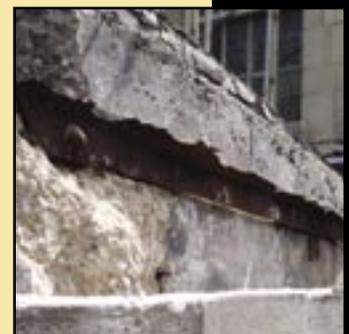
These photographs (*See photos P and Q*) show examples of deteriorated steel uncovered during the demolition stage of our work. Once steel supports have this much rust, there is no choice but to replace it.

The first step is to expose all steel. After a determination is made by the engineer, removal and replacement can begin. New steel will match the existing in strength and configuration or may be up-sized to provide additional support. All new steel will be primed with a rust inhibitive primer, painted and flashed. These steps are essential to protect against future rusting necessitating
