DESIGN INSTALLATION SYSTEMS, INC.

re:news

Vol. 3, No. 1

March 2005

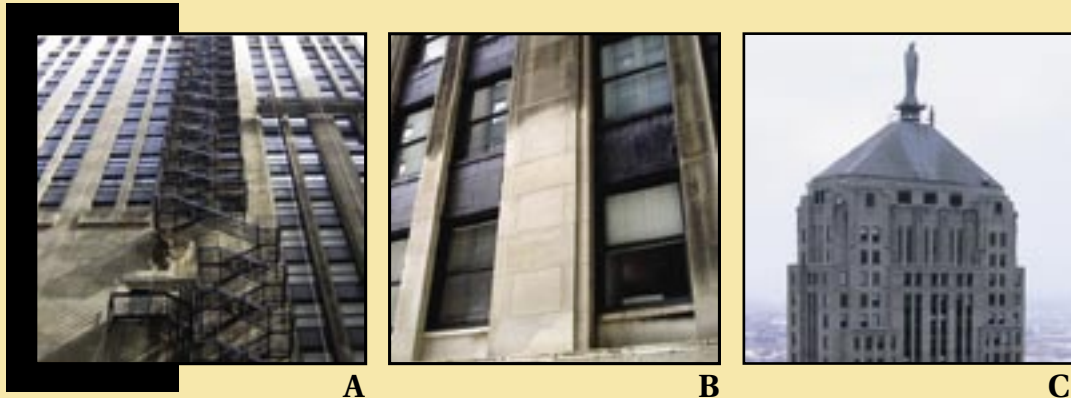
During the cleaning operation the wall surface is closely examined, and any defects in the wall are addressed. Years of caulking and tuckpointing repairs will be removed along with any remaining original caulking and mortar. All caulking will be replaced and mortar joints will be repointed. This will give the building a more uniform appearance and give the exterior a fresh start.

Finally, signs of deterioration of steel inside the wall are noted, and investigation openings are made. At these openings, steel rehabilitation is performed to reestablish integrity of the wall that surpasses its original construction. Any chipped or cracked stones are then replaced and the wall restoration is complete. *(See photo E)*

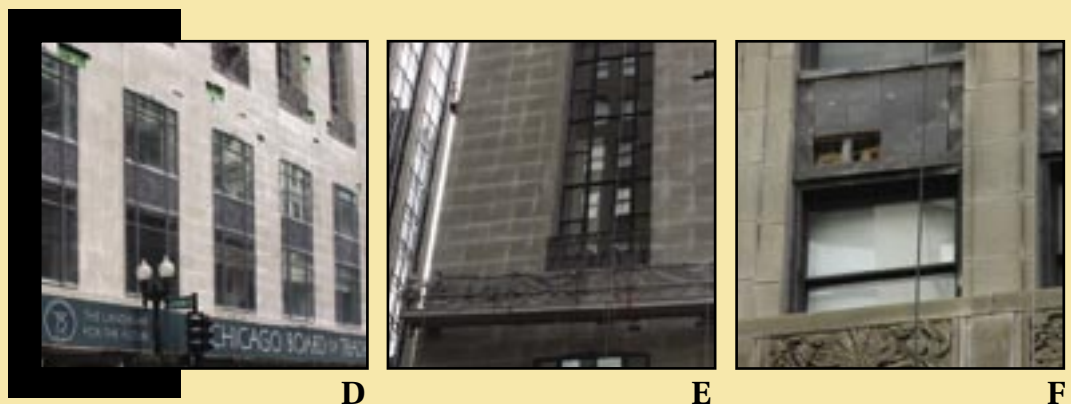
Early in the restoration process the terra cotta panels also are examined. Although DIS can fabricate the needed limestone replacements, terra cotta samples must be removed and sent out for matching and fabrication. This is a time-consuming process and is started as early as possible to minimize construction delays later. *(See photo F)*

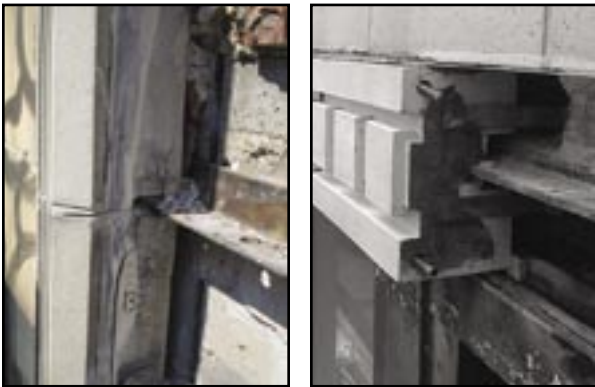
As a material for new construction, terra cotta was most popular between 1900 and 1940, at the time many modern structures were clad. It is used in new design today but is most commonly found in restoration projects. Terra cotta is a fire-baked, glazed masonry unit. Rather than being stacked on a structural base like brick or block; terra cotta typically is hung or “tied back” to the structure using hooks

and dowels. Design Installation Systems has decades of experience in this type of construction. The restoration of terra cotta facades is both intricate and involved. No other aspect of restoration requires more preplanning, preparation and coordination. Our staff and field personnel have learned to work closely with field representatives of terra cotta fabrication specialists to minimize problems during all phases of terra cotta replacement.

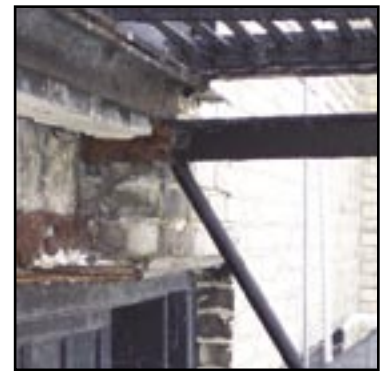
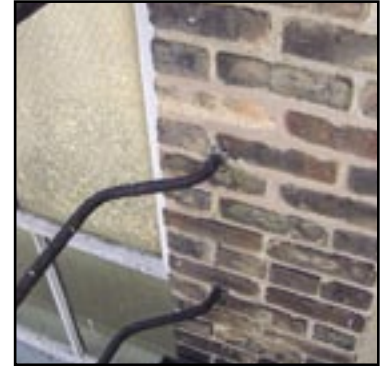
The Hyde Park Condominium, above, located on Chicago's South Side, is another example of Design Installation Systems completing exterior restoration that includes terra cotta work. The construction of this building includes decorative mullions and panels. These photographs show areas of removed panels as well as panels marked for removal. (See photos H & I)

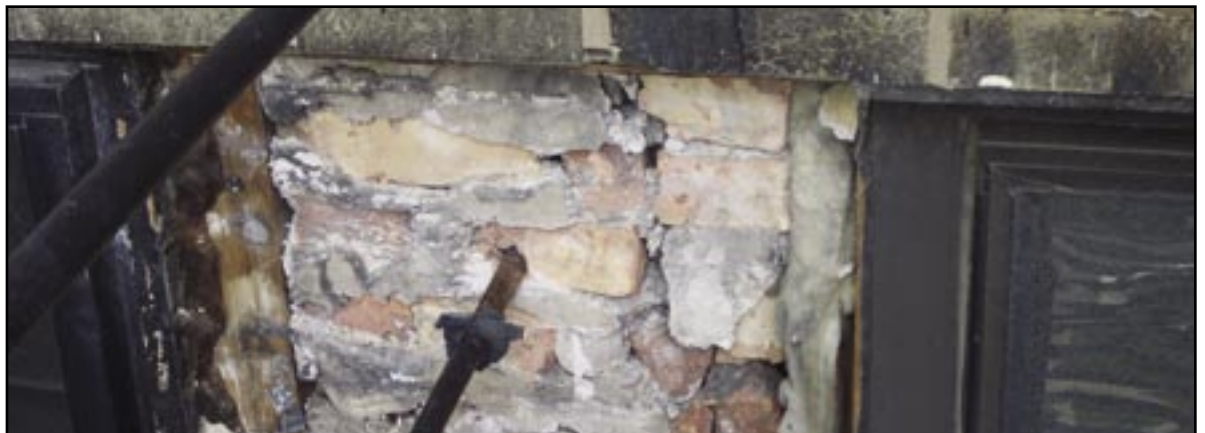
The large photograph shows an example of a steel support hook that the new terra cotta will be "hung" from. The steel will be cleaned and coated with a rust inhibitive paint prior to installation of the new piece. (See photo J)
